ART504

Case Studies & Regional
Work:
New Futures

Repair Strategy
Of
WHITCHURCH HOSPITAL
formerly
Cardiff City Asylum

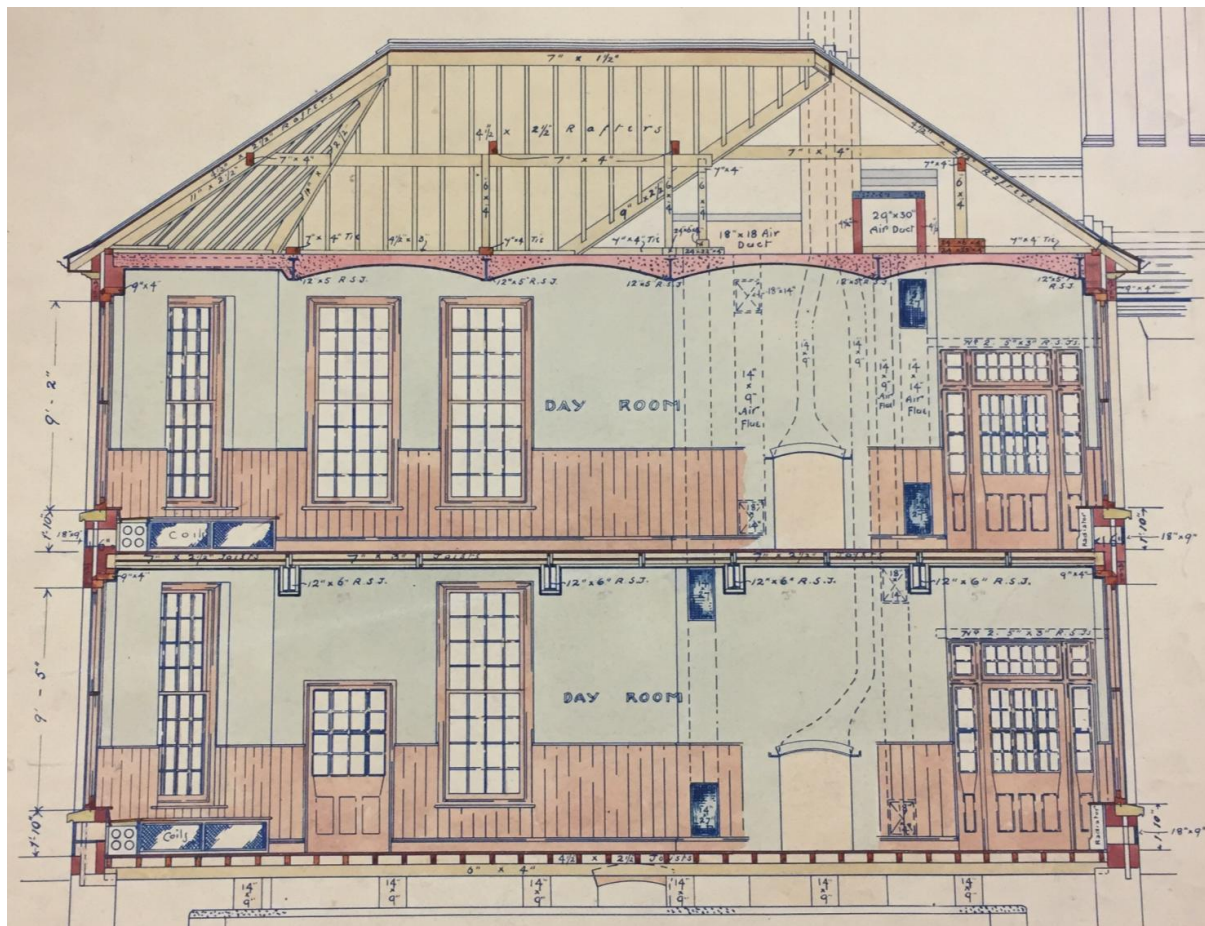
Image 1, (Britton, 2019) showing the timber framed constructed roof with the use of purlins and rafters, note the arched ceilings to the ceiling of the first floor, these being concrete fire-proof construction, Architects drawings referring to 'Dennett Concrete', being a patented fire-proof construction concrete, referred to as the Dennett's System or Dennett's Fire-proof Construction. (Rabun, 2000)

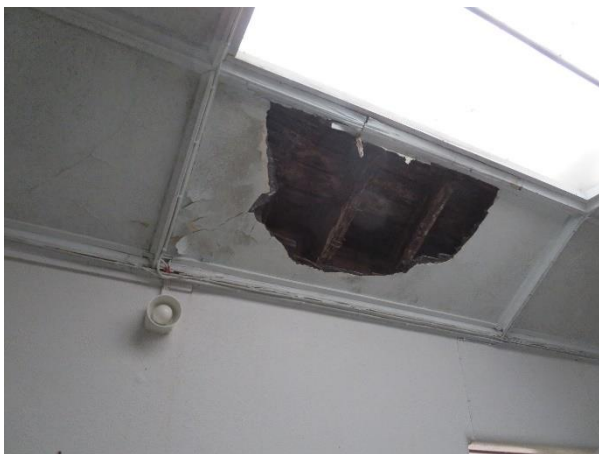
Image 2, showing area of ceiling decay attributed to roof defects (Branford, 2019)

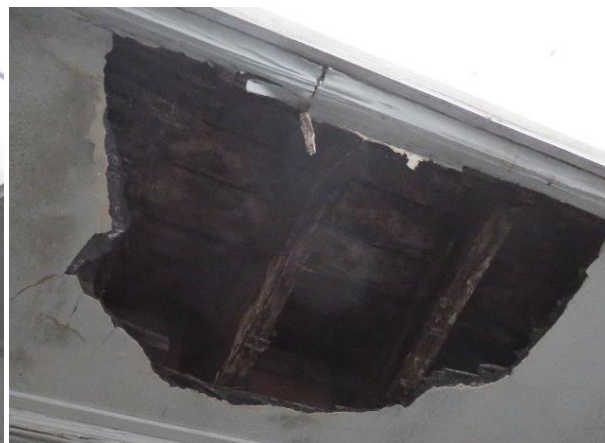
Image 3, close up of image 2

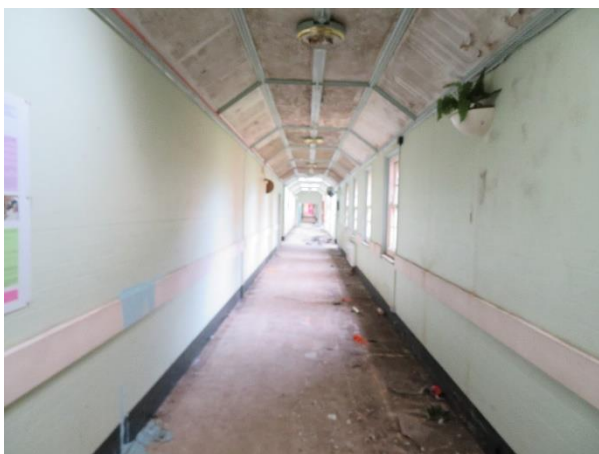
Image 4, showing the general condition internally (Branford, 2019)

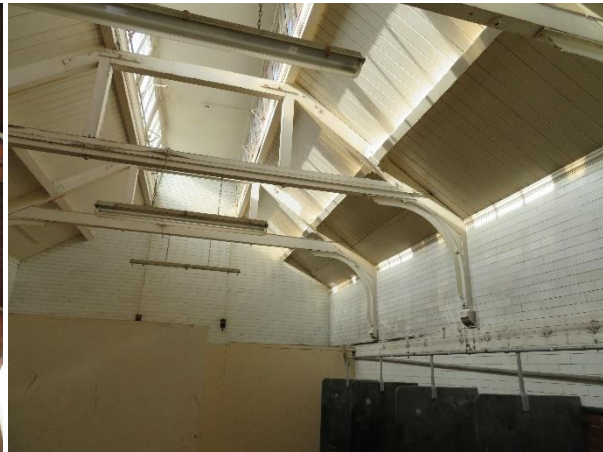
Image 8, Shower room - roof structure (Branford, 2019)

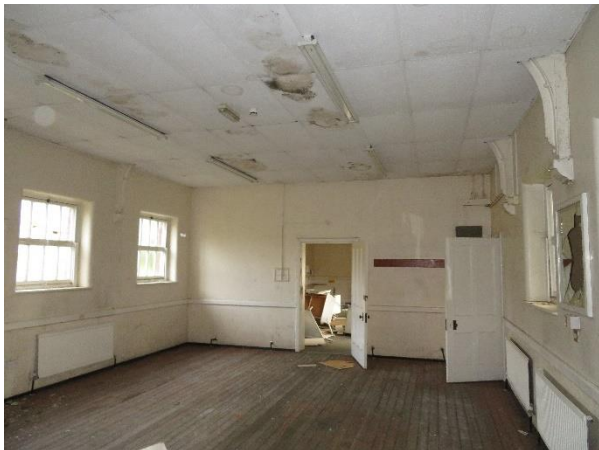
Image 9, Suspended Ceilings Showing condensation staining. (Branford, 2019)

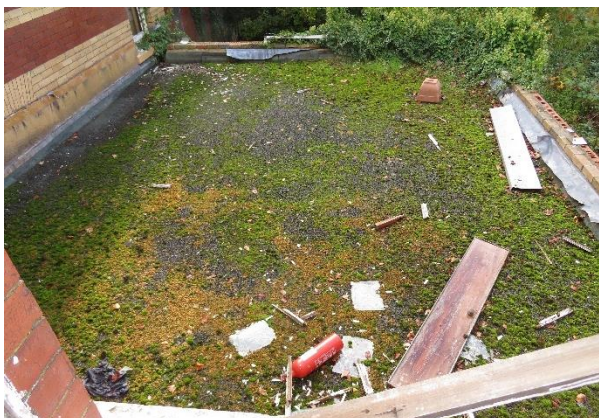
Image 15, Example of the flat roofs including evidence of vandalism. (Branford, 2019)

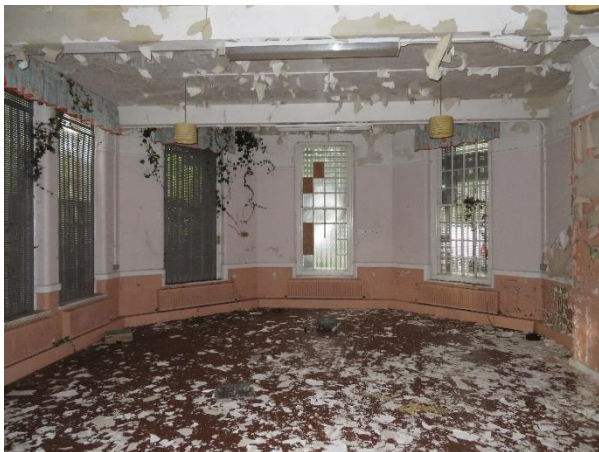
Image 18, Decoration decay attributed to poor ventilation and condensation (Branford, 2019)

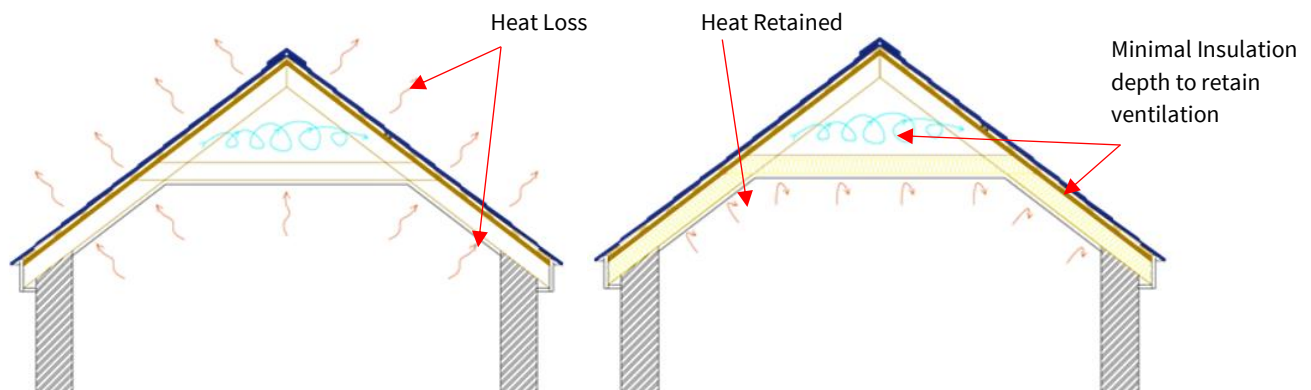
Image 22 & 23, showing existing thermal performance and potential results from thermal upgrades. (Branford, 2020)

The U-Value for the existing ceiling in good repair is calculated at 5.069544 W/m²K (refer to appendix B).

Using this data as a benchmark, the minimal thermal improvement would be a 92.2537155216%. This would significantly improve the thermal comfort within these areas and contribute to potential energy saving during the winter periods and reduce the solar gain during the summer periods, thus making for a more comfortable area to commute through.

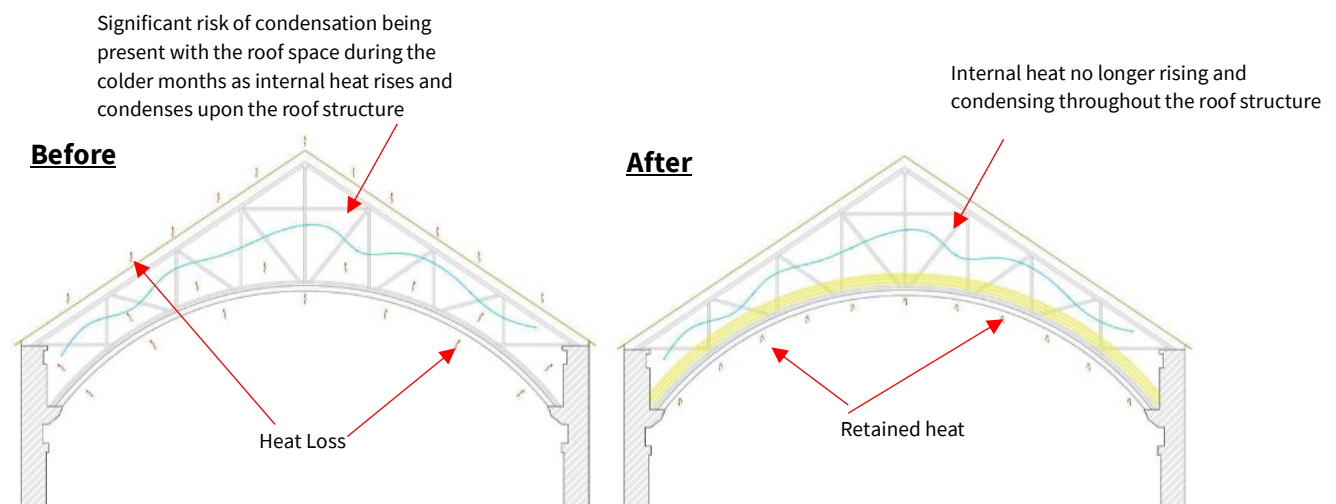
Image 24 & 25, showing existing thermal performance and potential results from thermal upgrades. (Branford, 2020)

The U-Value for the existing ceiling in good repair is calculated at 5.4502387 W/m²K (refer to appendix B)

Using this data as a benchmark, the minimal thermal improvement would be a 97.9043560055%. This would significantly improve the thermal comfort within these areas and contribute to potential energy saving during the winter periods and reduce the solar gain during the summer periods, thus making for a more comfortable area to inhabit and utilise.

In short 97.9% of the energy currently passing through the existing ceiling would be retained within the room. This would require less heating within the thermally upgraded rooms and reduce the risk of condensation being experienced within the roof space caused by heat rising and condensing on the roof structure. Thermally improvements here can provide the room with much wider future uses.
