Condition Appraisal

WHITCHURCH HOSPITAL

Cardiff City Asylum

APPRAISAL OF CURRENT CONDITION

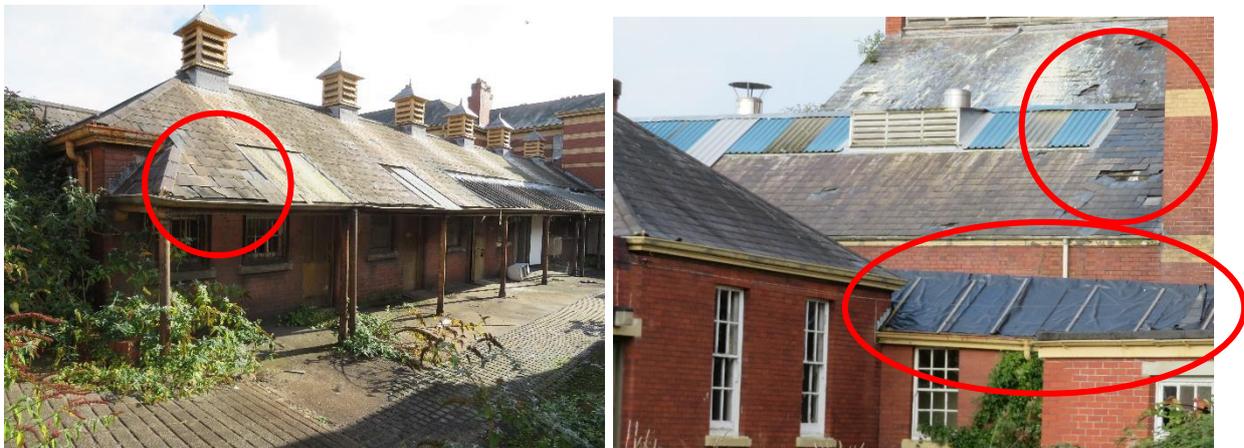
Several slates throughout the multiple roof elevations are damaged or missing. This would appear in the main to be due to vandalism post closure whilst additional areas appear to be a result of natural degradation. Natural defects within the slates over time are exposed to weather extremes, natural faults can be exposed to decades of freeze and thaw actions until eventual failure. Repairs and maintenance particularly that require tradesmen to gain access over roofing materials can lead to damaged slates, whilst the majority of these can be identified immediately some damage may go undetected for several years, by which time the ravages of time cause the damaged slates to fail, crack and slip.

Images 30 & 31, Slate roof covering defective areas, and temporary coverings, source: Author's own 2020

It is recommended that a thorough investigation is carried out to all roof elevations to determine the extent of failures. Repairs are anticipated to require the careful removal of damaged slates and provided the underlying structure is of good, matching replacement slates can be installed. Fixings to be appropriate to the installation access, these vary from copper clout nails to various forms of hooks dependant on the repair method.

Larger repairs including areas of vandalism are anticipated to require complete slate covering stripping to allow for timber roof structure repairs due to exposure to several years of moisture ingress. Assessment is required to determine the extent of structural repairs; however, it is assumed that timber sarking boards, and isolated trusses, rafters and wall plates would require extensive repair/replacement.

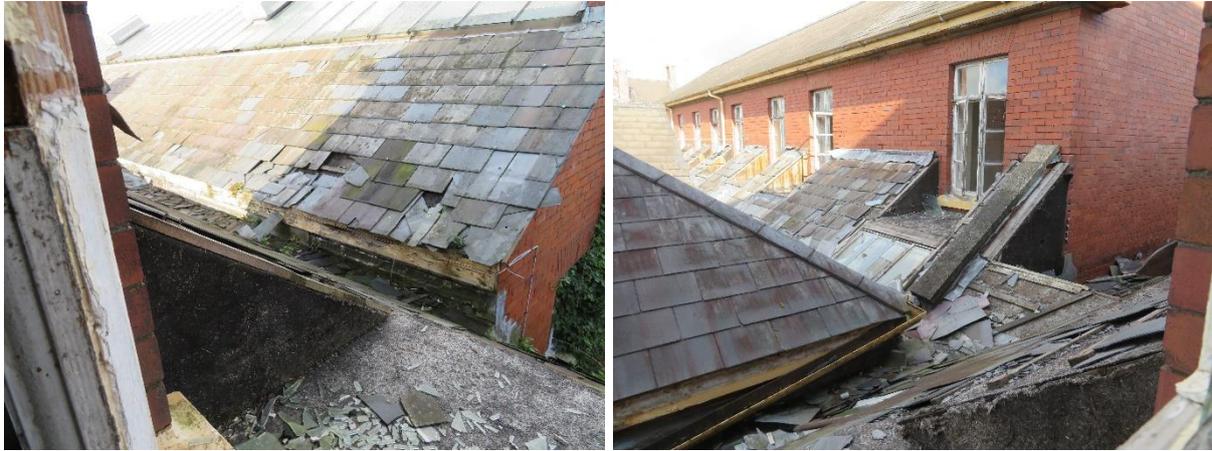
In several areas the evidence of lead theft is apparent, to gain access to these areas slate roof coverings have been trodden on and in areas slates have been crudely removed to enable access to the lead. This has led to extensive slate damage and exposed the underlying roof structure to moisture ingress. Over time this moisture ingress will lead to extensive decay of roof timbers, internal timbers, plasters, flooring and services.

Images 32 & 33, Damage caused by lead theft, source: Author's own 2020

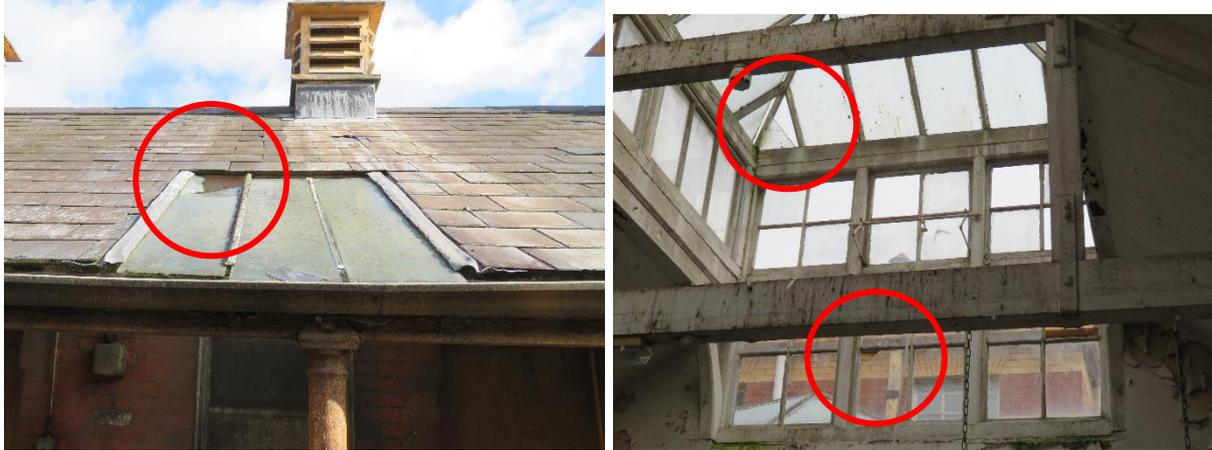
Images 36 & 37, Areas of damage, source: Author's own 2020

Isolated areas of damage were present in several areas, these included loose panes due to degraded fixings, and broken panes due to time and possible impacts due to access etc.

Within the laboratory several panes were completely missing, this has allowed access to pigeons, and consequential the rooms below have suffered from quantities of guano.

Glazing within these areas can be replaced and secured with putties, glazing bars and steel retaining clips as per original. Frames should be assessed prior to glazing replacement, with decayed sections replaced with like for like materials.

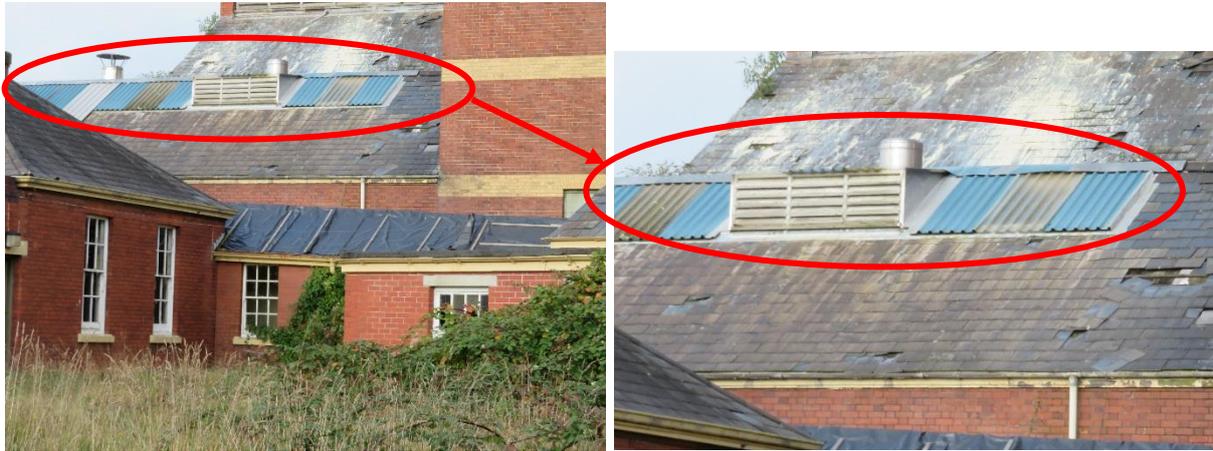
Images 38 & 39, Corrugated steel sheet coverings, source: Author's own 2020

The resin/fibreglass corrugated sheets appear to have weather considerably and degraded under UV light.

These within the near future would require complete replacement.

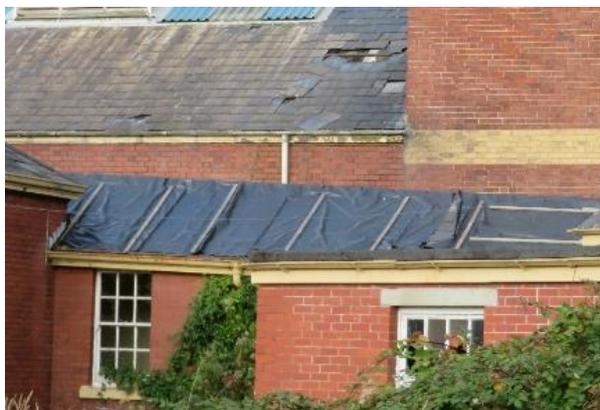
Several areas of plastic sheet have been used as a temporary roof covering, it is believed the original slate coverings have been removed for reasons unknown. It is not known how long this temporary sheeting has been in place, however, it is reasonable to assume that a quantity of timber degradation has occurred as a consequence.

Image 40, Temporary plastic sheet coverings, source: Author's own 2020

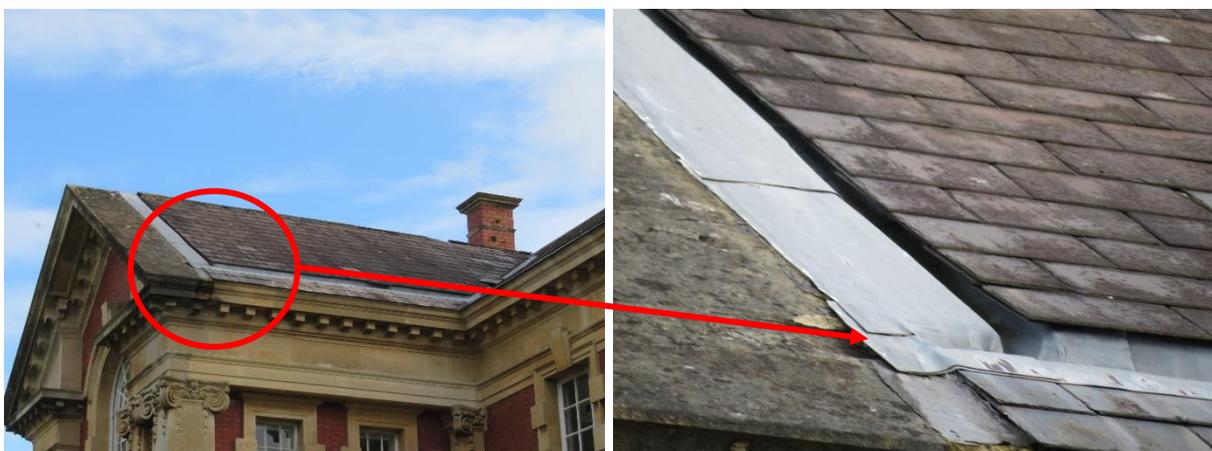
Images 42 & 43, Lead coverings, source: Author's own 2020

Here lead has been lapped over the coping stone in an attempt it is assumed to prevent moisture ingress from damaged box gutters and flashings behind.

Assessment of these lead repairs and underlying defects are required prior to determining the course of repair method. It is anticipated that the original lead used to line the box gutter including flashing have fractured possibly due to excessive lengths of lead, poor detailing, previous repairs and general degradation of the material.

Removal of the repair sections of lead are required to provide access to the original; box gutter and flashings. It is assumed that replacement of the lead sheet within the box gutter will be required. An assessment of the flashing to be taken upon inspection. All lead work to be carried out under the Lead Sheet Association Guidelines.

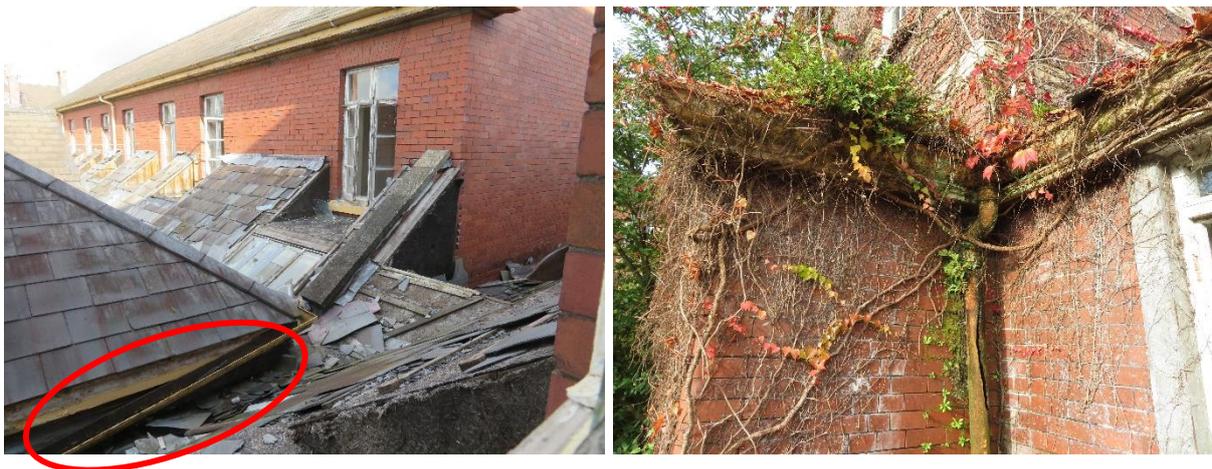
Several areas of damage can be observed about the hospital were significant damage has occurred. Damaged brackets and supporting structures have failed and in turn led to failure of the rainwater gutters. Additionally, missing and damaged sections fail to effectively carry water away from the fabric of the building allowing moisture to ingress at the heads of walls, run over external elevations including windows, whilst also splashing at the foot of external walls. All of these areas of moisture ingress accelerate material decay through decayed timbers, saturated brickwork which during freeze and thaw actions of the weather may lead to spalling of the brickwork, accelerated corrosion of ferrous wall ties and degraded mortar joints.

Excessive moisture at the base of walls can lead to foundation defects including under supported foundations were rainwater washes away subsoils and or soften supporting soils, both leading to structural damage of varying degrees. In several areas, vegetation has built up at discharge points preventing the effective discharge of rainwater. These areas of vegetation allow rainwater to overflow in these localised areas leading to similar damage as noted above with the addition of the extra loads placed upon brackets and supports, this increases the risk of support failure due to overloading.

Images 44 & 45, Defective RWG's, source: Author's own 2020

It is advised that all vegetation and debris is removed from gutters, downpipes and gullies. Damaged and missing gutter and downpipe sections are replaced including any joint gaskets (putties etc). Ensure all supporting brackets are complete and secure including replacing damaged items as required. Additionally, ensure all supporting fascias both timber and stone are in good repair, damage to these areas require extensive works and the removal of large sections of RWG. Timber fascias to be replaced with suitably matching size and grade timbers. Stone repairs to be assessed, allow for isolated repairs and complete stone section replacement should damage severely compromise adjoining fabric.

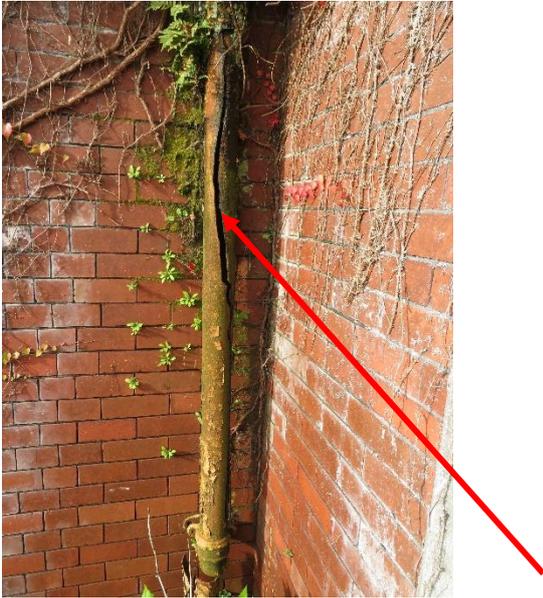
Rainwater downpipes to an area abutting west corridor and the 2nd west wing has severely cracked and been expanded down the length of the pipe, this is due to blockages within the downpipe that have held a quantity of rainwater, this has consequentially frozen, the expanding rainwater has fractured and expanded the pipe beyond viable repair. Additionally, fixing brackets have failed both in fixings and stability this has led to sections of downpipes dislodging, breaking the path of flow for rainwater to be delivered to gullies etc. As above failures like these increase the moisture deposited within building fabric and the base of walls, increasing the risk of building fabric failure.

Image 46, Defective cast iron downpipe, source: Author's own 2020

Complete replacement.

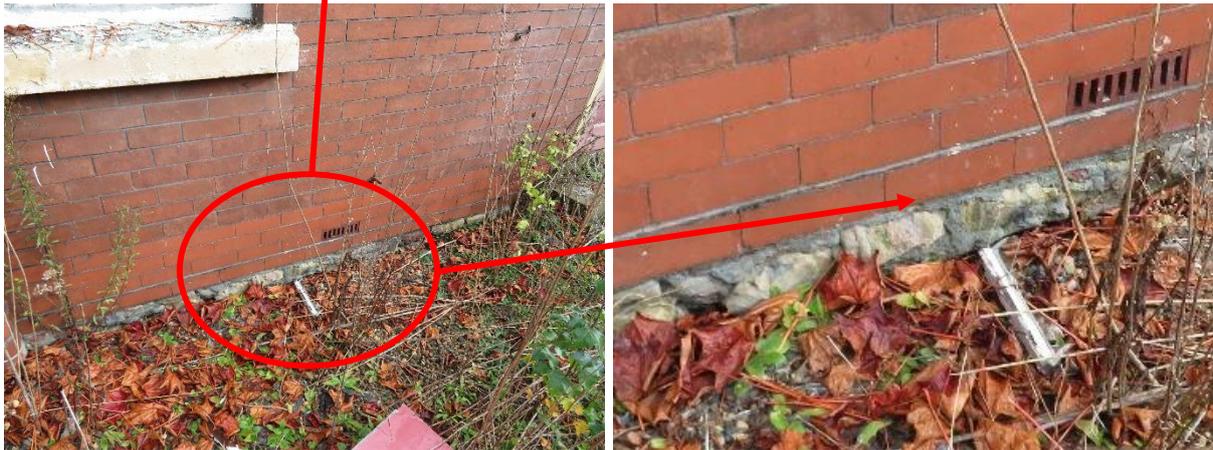
The construction between the concrete strip foundations and DPC levels in the highlighted area abutting the west connecting corridor shows an area of rusticated and rubble sandstone. Throughout the viewed areas this appeared to be an isolated change in construction, however it is assumed there may well be additional areas of similar construction.

Images 50 & 51, Below DPC construction material showing as rusticated stone, source: Author's own 2020

These works do not appear to be part of a previous repair and one can only assume this detail forms part of the original construction. The change in material may be attributed to the differing load due to storey height of the connecting corridors.

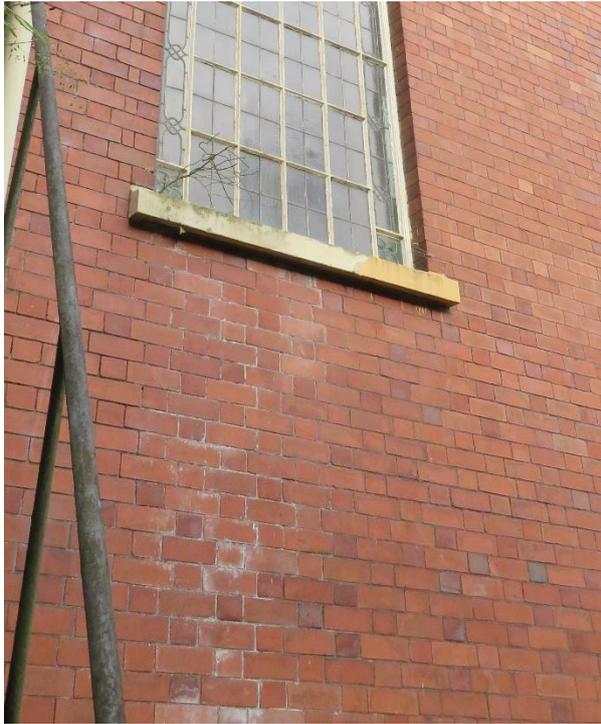
Evidence of salt migration can be seen in areas where RWG's are in a defective condition. Concentrated moisture ingress allowing soluble salts to migrate through masonry and evaporate on external façades, resulting in the white staining to the mortar joints.

Image 52, Soluble salt migration, resulting in white staining, source: Author's own 2020

Upon RWG's being repaired etc, the soluble salt staining can be gently brushed away, this may be required several times. Do not remove with pressure washers etc as this introduces large amounts of water into the building fabric under high pressure causing damage to surface and exacerbating the migration of soluble salts.

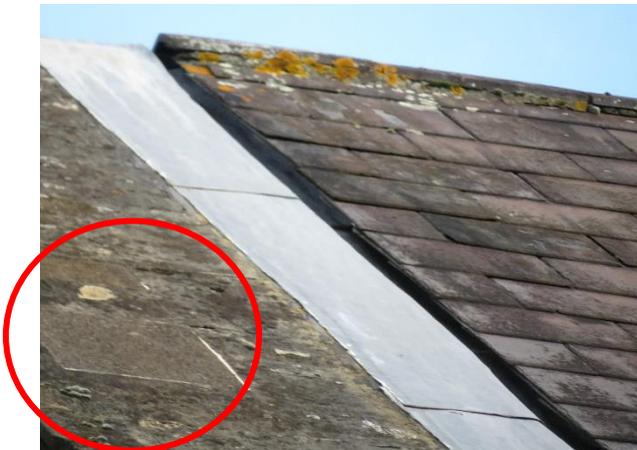
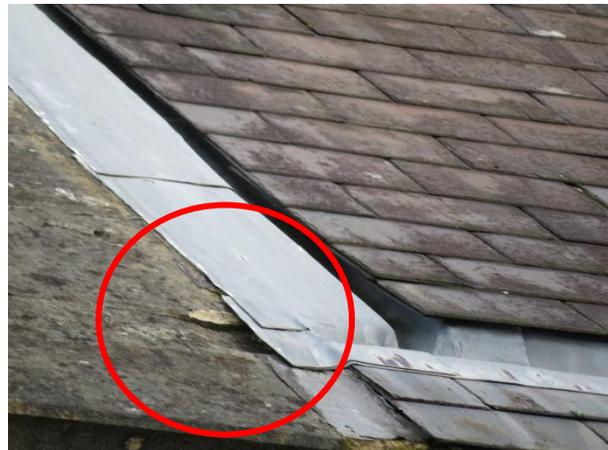
The copings to the right of the portico has signs of previous repair and isolated stone degradation.

Images 55, Bathstone historic repairs & 56, An area of damage, source: Author's own 2020

Repairs appear to be in good condition, additional areas noted require further investigation to determine the requirement for intervention.

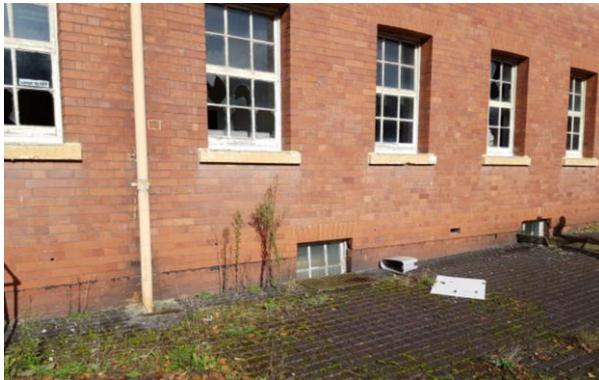
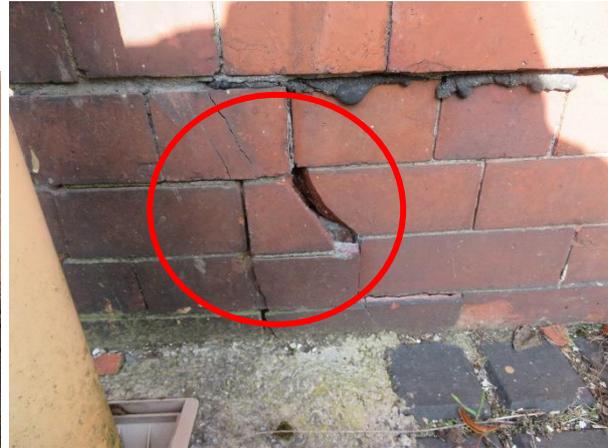
The external wall to the south elevation of the store/workshops has an area of fractured brickwork a result of building/brickwork creep. The movement across the elevation measuring approximately 21.52 Lm to the courses of brickwork directly above the bituminous DPC course. Additionally, there are vertical cracks below the window aperture to the east gable of the store/workshop.

Images 56 & 57, Building creep showing on the south elevation of the stores building, source: Author's own 2020

Failing further investigation to determine all contributing factors the existing evidence shows that the front elevation has slipped approximately 40mm of the line of foundation. The implied loads relating to unknown factors cannot be known at this stage, however the presence of vertical cracks to the base of windows on the first floor gable walls suggests that only the front façade and partial areas of the flanking walls have moved. Evidence does suggest this is unlikely to relate to a foundation related issue. The DPC being bituminous can be seen to have expanded out of the joint, this a result of either the forces applied down through the masonry thus squeezing and compression of the DPC and or hot weather particularly as the façade faces south and has a large surface area combined with the abutting paving being black blue and heat absorbent. One or more of these factors could have resulted in the observed movement. A full investigation

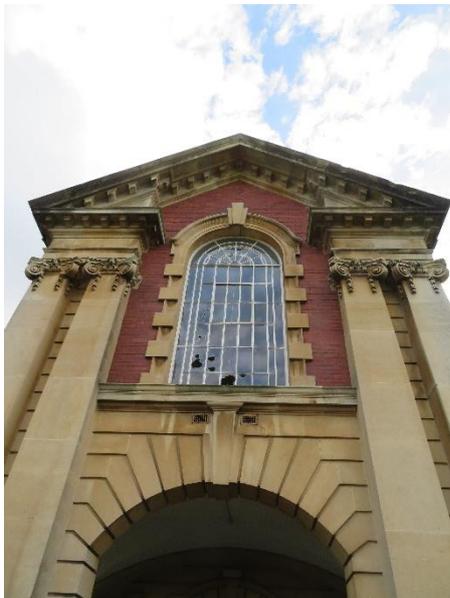
Image 59, North elevation wrought iron classical arched window, source: Author's own 2020

The centre hung casement may well be painted shut as would be suggested from ground floor viewing. Several panes of the glazing have been broken by what appears to be mindless vandalism. These broken panes allow rain and wind to freely enter the building creating internal damp environments, rain can ingress to internal elements of the window structure leading to eventual decay of the fabric. Corrosion in these areas may lead to the eventual loss of historic fabric.

Carefully remove the build up of several decades of paint, Note the paints used here are highly likely to be lead based. Care is to be observed, further information relating to working safely with lead can be found at: <https://www.hse.gov.uk/lead/>

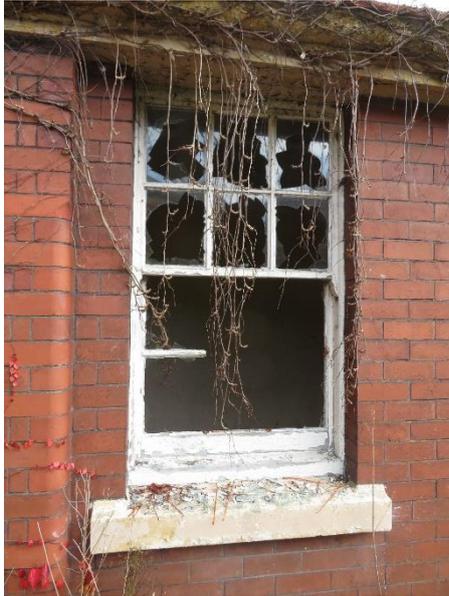
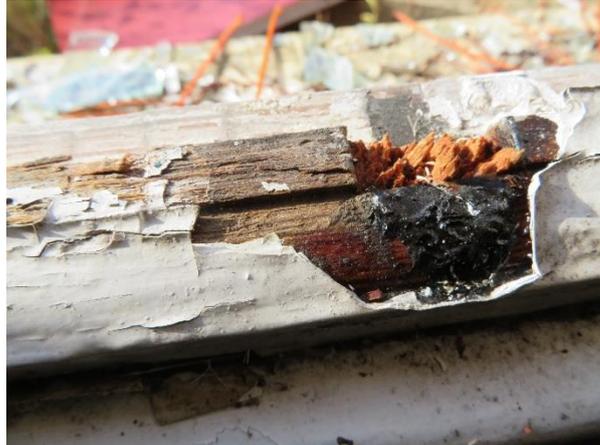
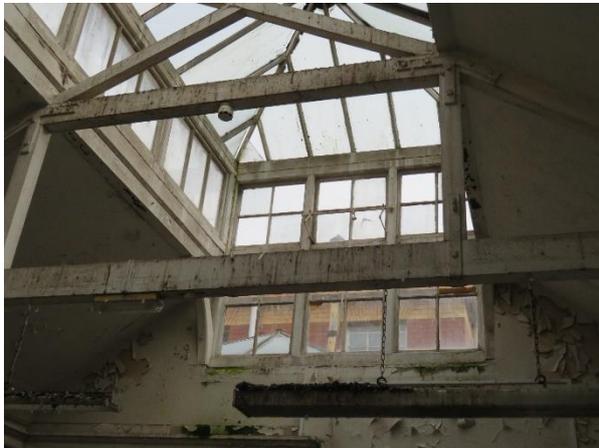
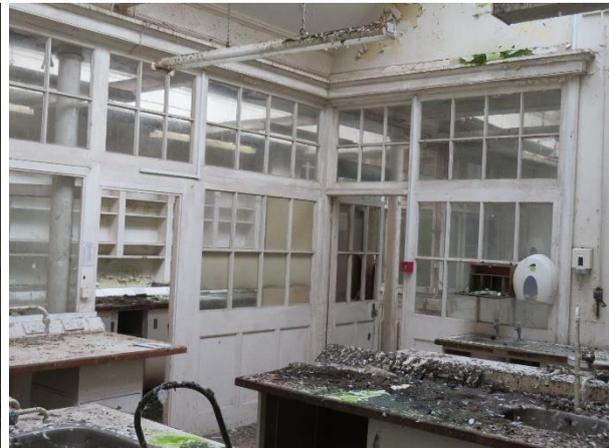
Whilst on the limited access tour the majority of glazing in all timber windows and several box frame sashes had experienced vandalism. This has led to the building as a whole being exposed to the ravages of the weather and wildlife. Decay had begun to set into the exposed timbers of the frames and sashes.

Images 65, 66, 67 & 68 , showing damage and decay to timber windows throughout, source: Author's own 2020

A thorough inspection of all windows and frames are required to determine the extent of repairs. On findings during the tour repairs are expected to be lower frame and sill repairs/replacements using quality joinery grade like for like timbers, extensive lower sash frame repairs. All putty and damaged glass removed, and frames cleared of all paints prior to re-glazing and decoration. Allowance should be made to replace all sash cords etc.

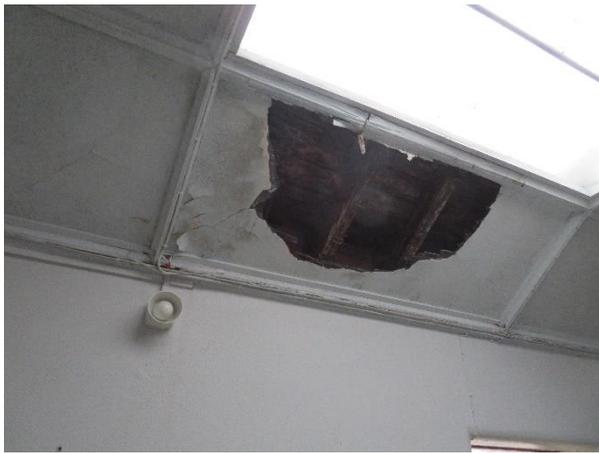
Within the corridor to the southwest elevation the results of moisture ingress have caused material degradation as seen by decayed ceiling plasters, the decay here extends from roof structure saturation and assumed decay, timber lath decay and steel fixing corrosion and saturation of plasters. This results in the failure of ceiling fabric.

Image 69, Damage to ceilings due to water ingress, source: Author's own 2020

Upon external sources of moisture entry being addressed and structural timbers replaced where required, remove all decayed plaster, timber lath, areas where fixing corrosion has occurred but lath and plaster are in good condition can be re-secured with proprietary fixings. Like for like laths can be secured with like for like fixings or a non-corrosive alternative and new matching lime plaster applied and finished as existing.

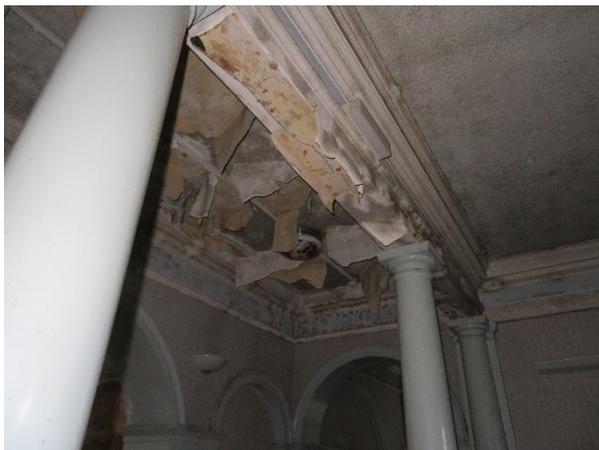
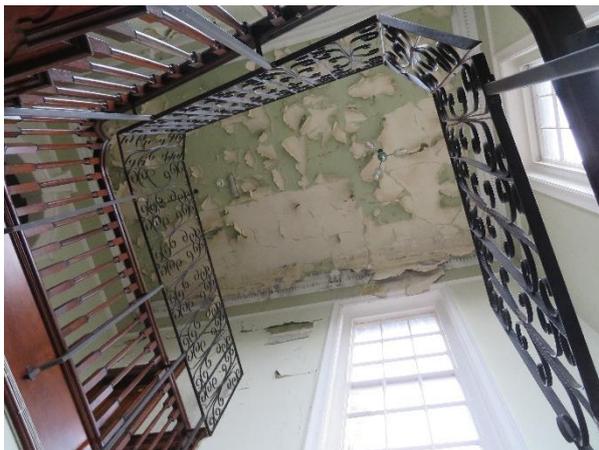
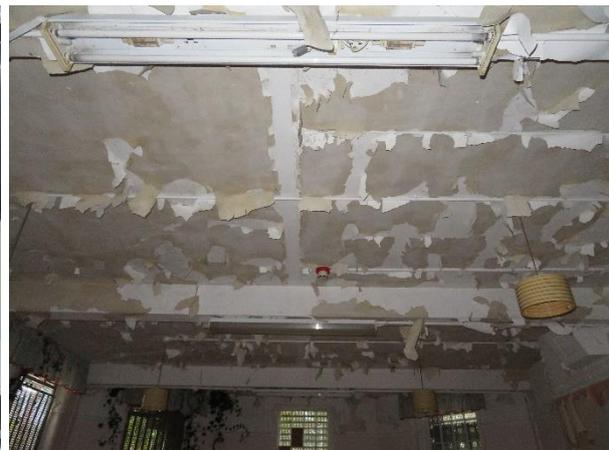
It is believed moisture ingress resulting from defective roof coverings are contributing to ceiling and decoration decay throughout the building particularly within the foyer and stairwell of the main entrance. Decoration within these areas are believed to be petrochemical based, these inhibit the transfer of moisture vapour. As a result over time moisture ingress be it through external defect or internal humidity builds up with plasters etc and causes the finishes to deboned resulting in peeling and flaking paint.

Condensation levels within the hospital are also high, resulting in paint finishes failing evident in areas of peeling and flaking paint, this is prominent in areas were modern petrochemical paints have been used. As above these paints restrict moisture vapour movement and cause considerable quantities of moisture to be held within materials, at which point the moisture held becomes so great as to blow the adhesion of the paint from the fabric to which it was held. Were more breathable paints have been used these affects are considerably lessened. Mould growth is present throughout the majority of the ceilings, this being a consequence of the high humidity and condensation.

Images 70, 71 & 72 showing the effects of moisture ingress and condensation, source: Author's own 2020

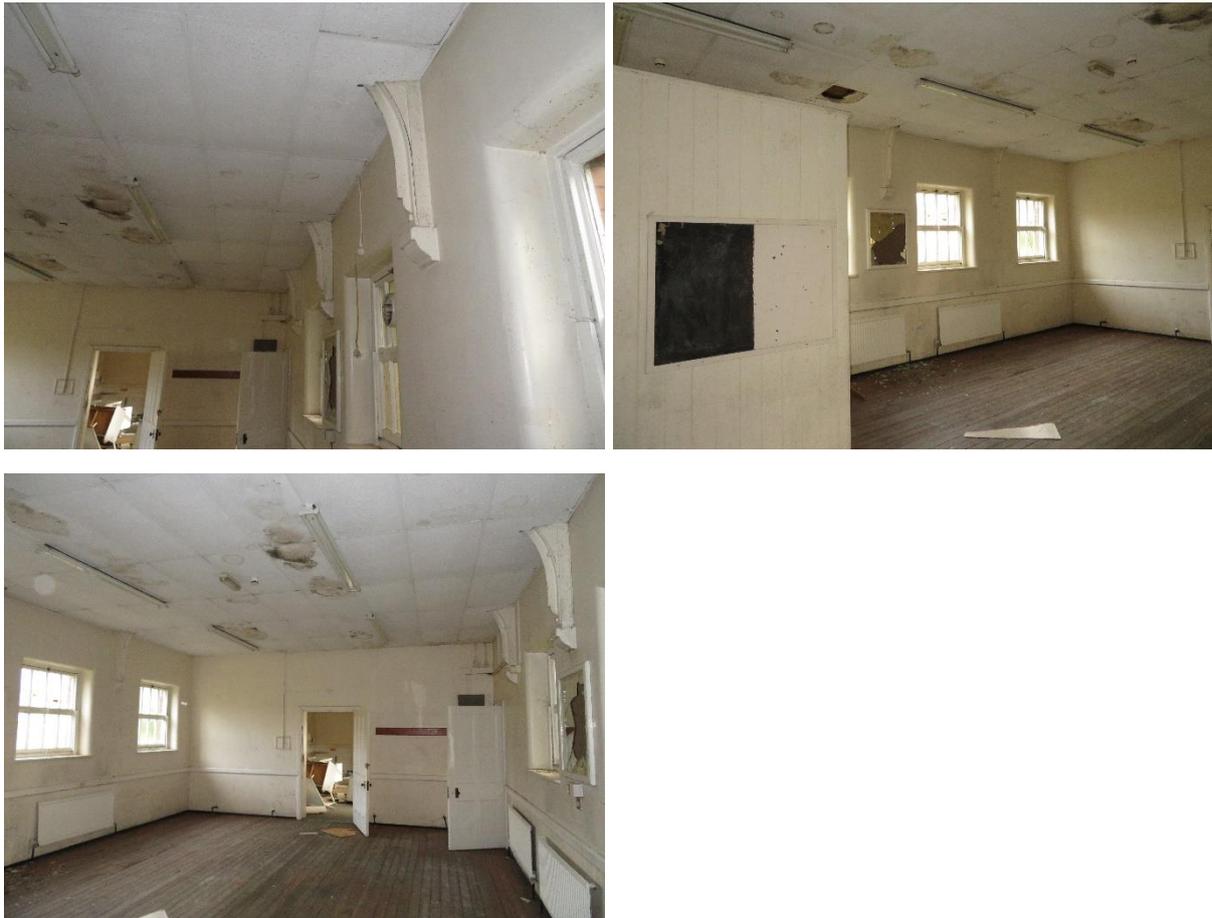
Image 73, 74 & 75 Damage to believed asbestos suspended ceiling due to condensation, source: Author's own 2020

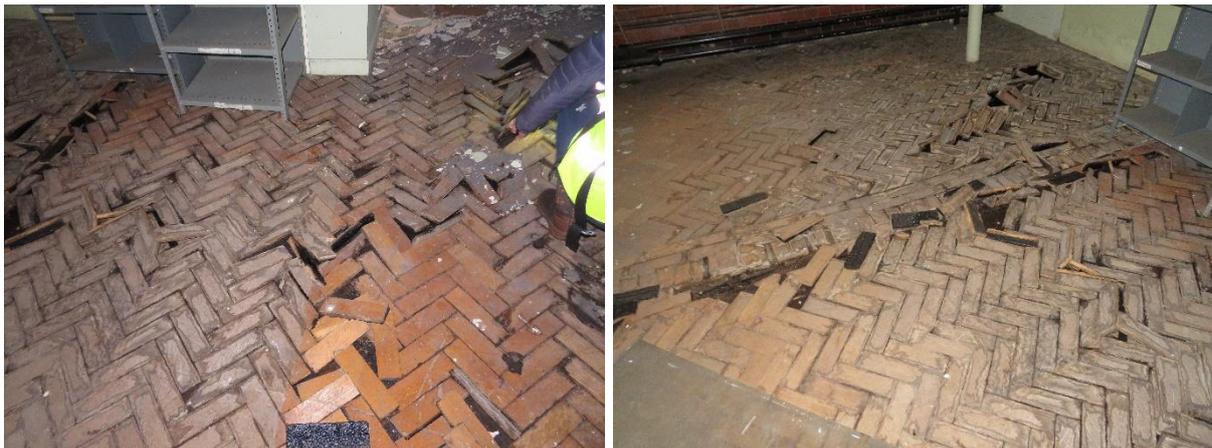
Image 76 & 77, Damage to timber parquet flooring due to water ingress, source: Author's own 2020

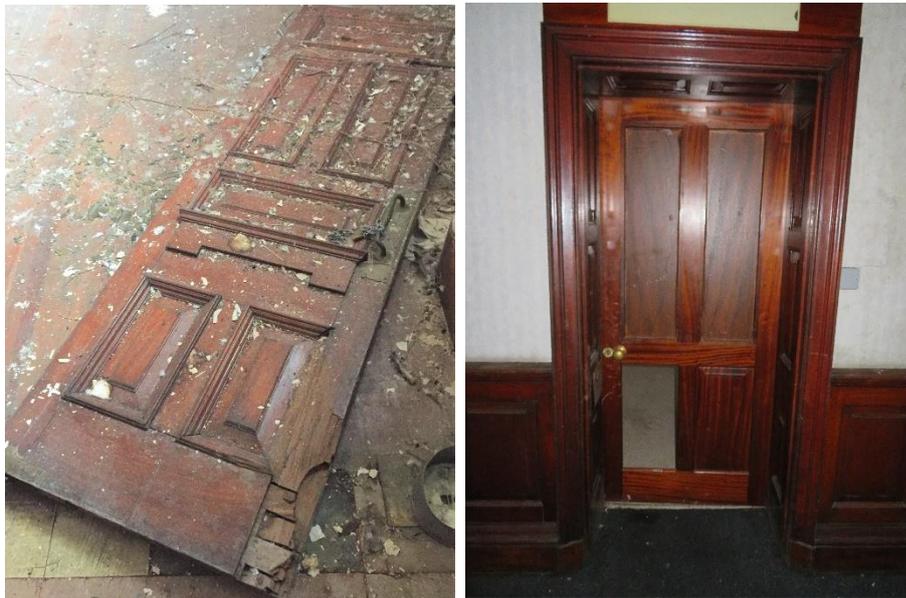
Several of the doors throughout particularly within the main reception area are damaged, believed a result of vandalism.

Image 82 & 83, Damage to internal doors due to believed vandalism, source: Author's own 2020

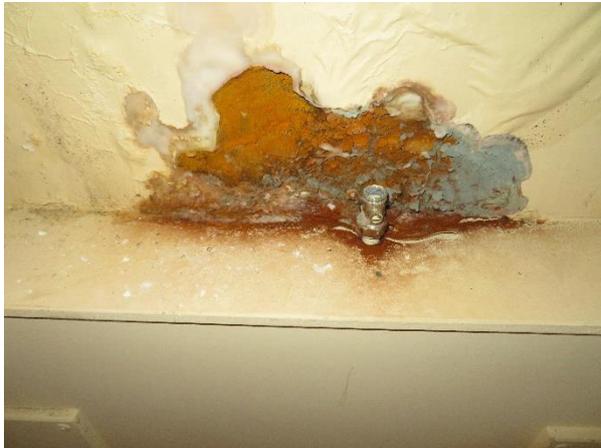
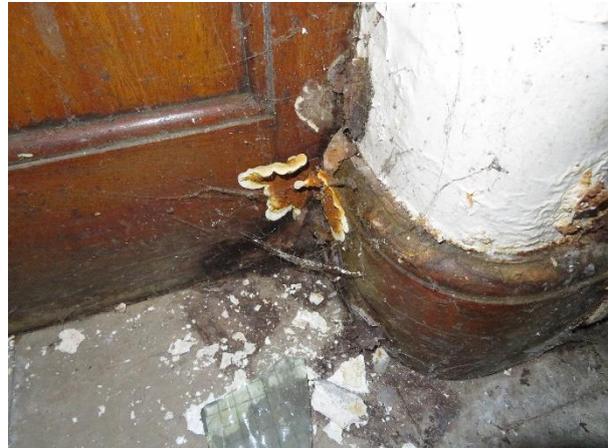
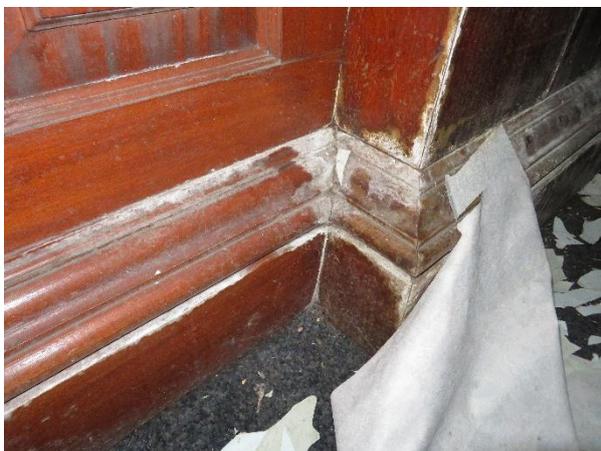
Images 84, 85 & 86, Wet rot (Coniophora Puteana) at various stages, source: Author's own 2020

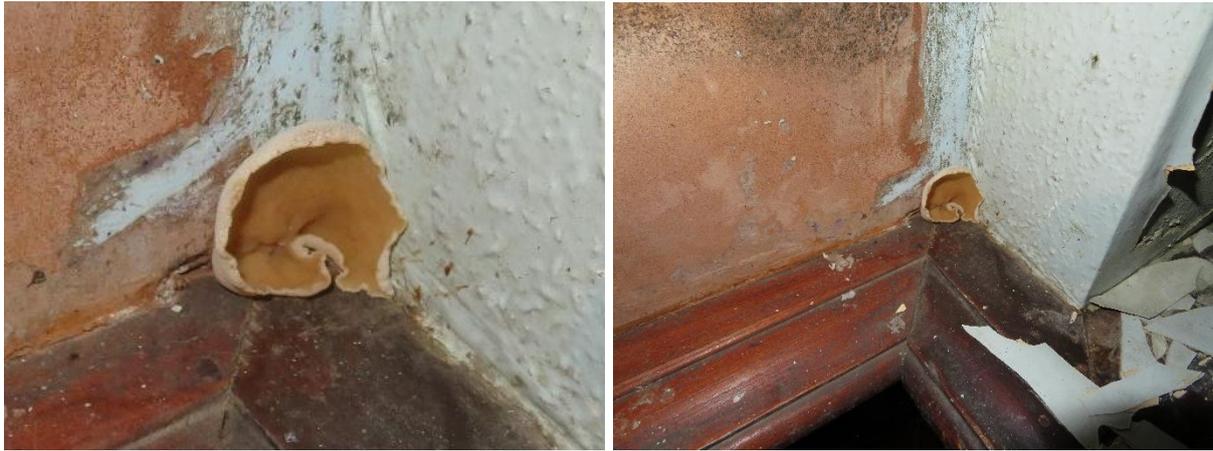
Image 87, Believed Cup Fungus (Peziza Domiciliana), source: Author's own 2020
