Condition Appraisal

WHITCHURCH HOSPITAL

Cardiff City Asylum

APPRAISAL OF CURRENT CONDITION

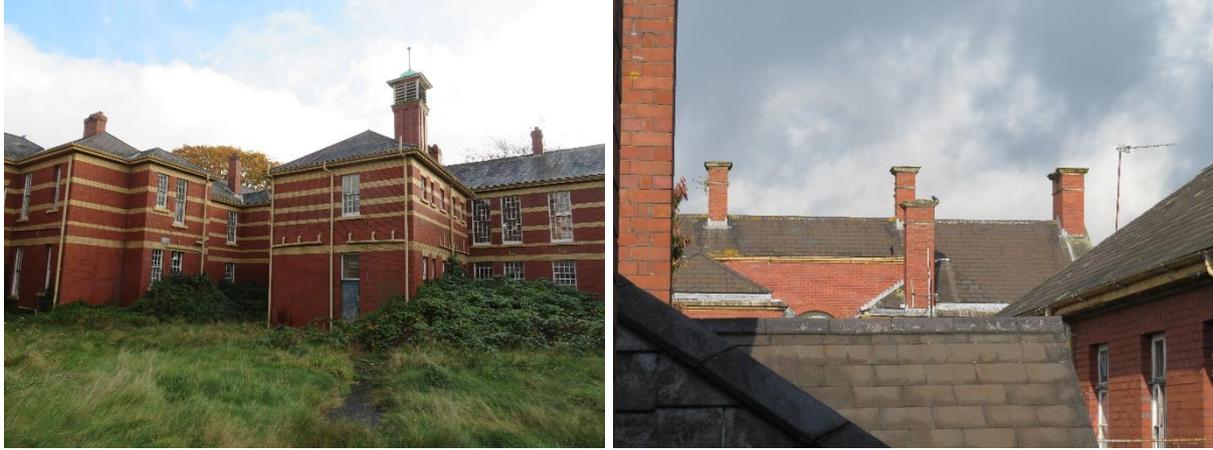
Image 13 & 14, General roof structures throughout the construction, source: Author's own 2020

Roof structures did not present defects structurally or due to external roof covering failings, however whilst not inspected several roof areas were covered in plastic sheeting suggesting potential defects, these areas were not inspected due to the prohibited access. It is recommended that a full and systematic survey is undertaken to determine the condition of all roof structures.

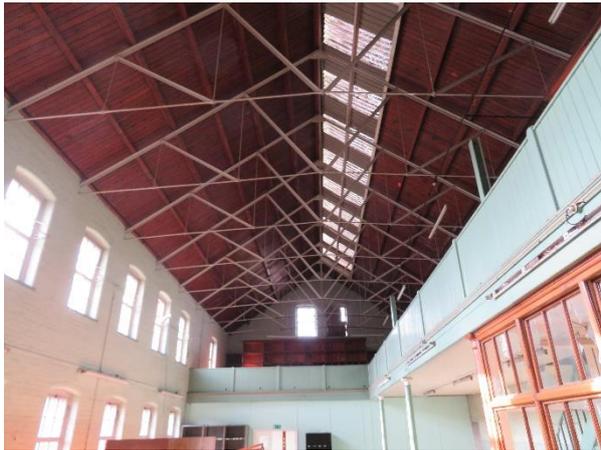
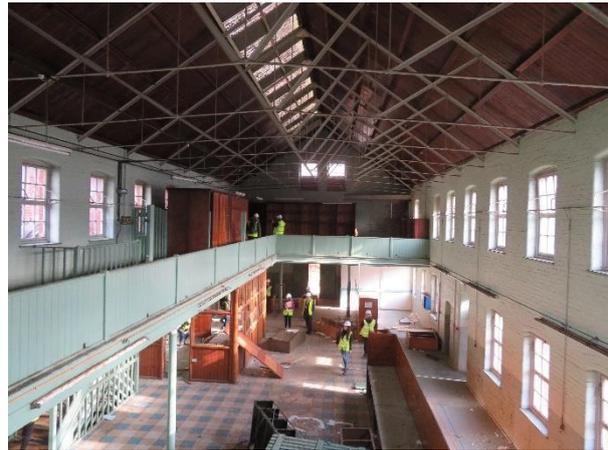
Image 17 & 18, Wrought Iron roof construction, source: Author's own 2020

At the time of the tour limited viewing opportunities did not present any areas of corrosion or defects that give cause for concern; however, it is advised that a full survey is carried out to determine the condition of all concealed materials.

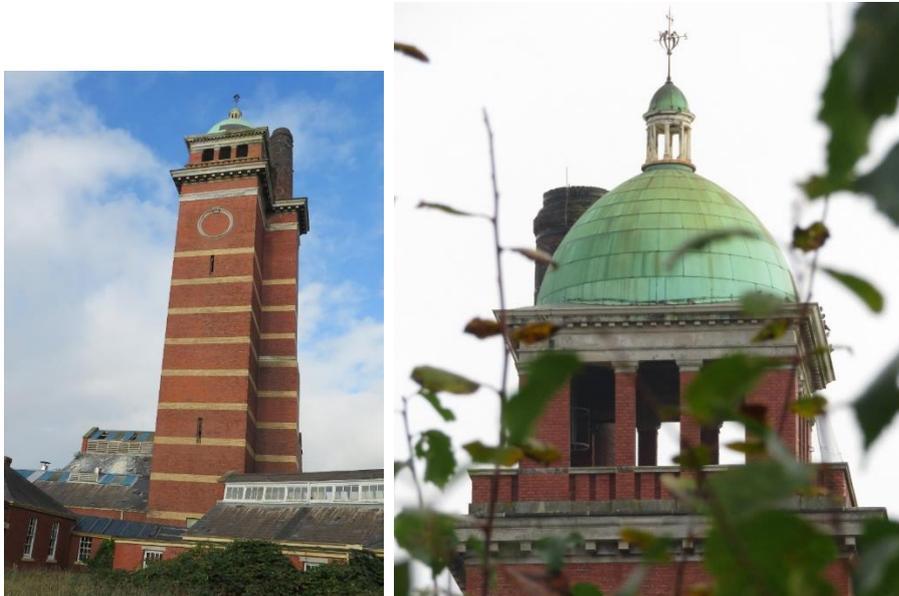
Images 34 & 35, Copper sheet coverings, source: Author's own 2020

From the visual inspection there appeared to be no obvious degradation of the material that would lead to internal defects; however, it is recommended that access be provided, and a thorough inspection be made of the roof coverings.

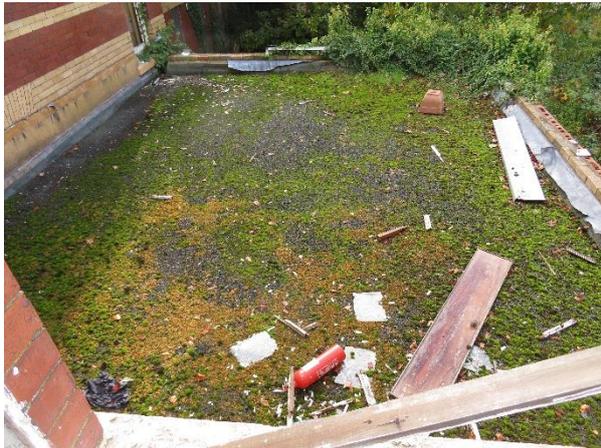
Image 41, Asphalt flat roof coverings, source: Author's own 2020

Whilst there was damage to lead flashings etc the asphalt roofing material appeared to be in reasonable condition, however it is assumed that a complete replacement would be necessary as it is believed there is limited life expectancy remaining in the covering.

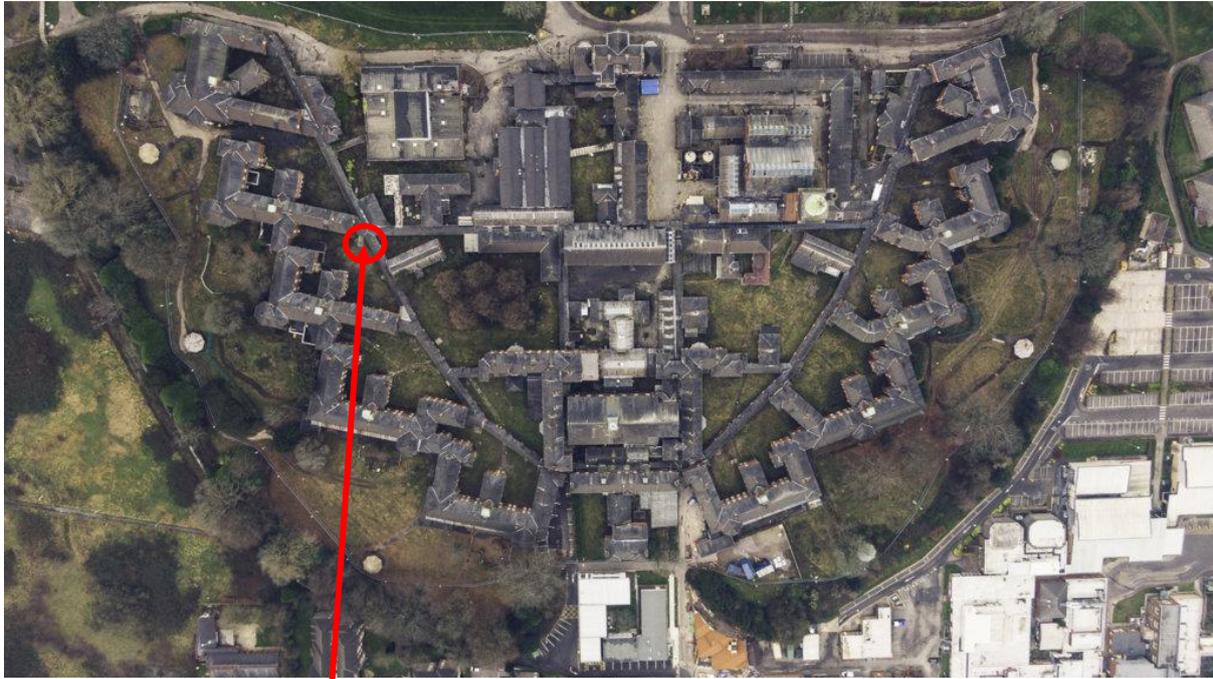
The construction between the concrete strip foundations and DPC levels in the highlighted area abutting the west connecting corridor shows an area of rusticated and rubble sandstone. Throughout the viewed areas this appeared to be an isolated change in construction, however it is assumed there may well be additional areas of similar construction.

These works do not appear to be part of a previous repair and one can only assume this detail forms part of the original construction. The change in material may be attributed to the differing load due to storey height of the connecting corridors.

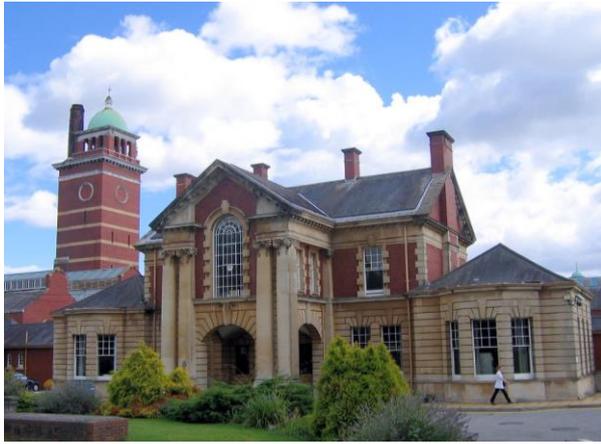
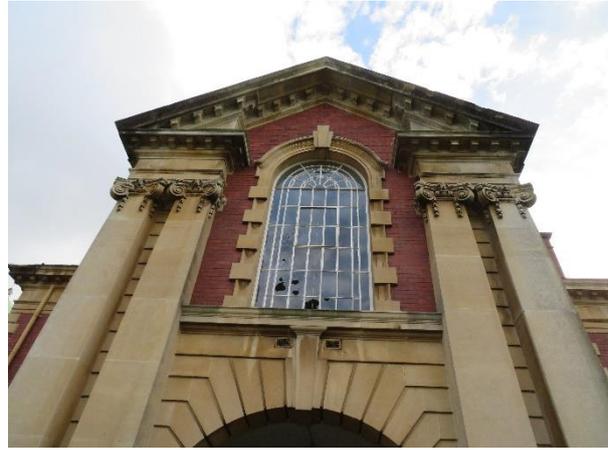
Images 53 & 54, North elevation showing bathstone construction with the water tower inset showing the use of Portland stone , source: Author's own 2020

The bath stone and Portland stone used throughout the front façade, portico and water tower etc. from the limited inspection presented no visual signs of decay or significant defects where identified.

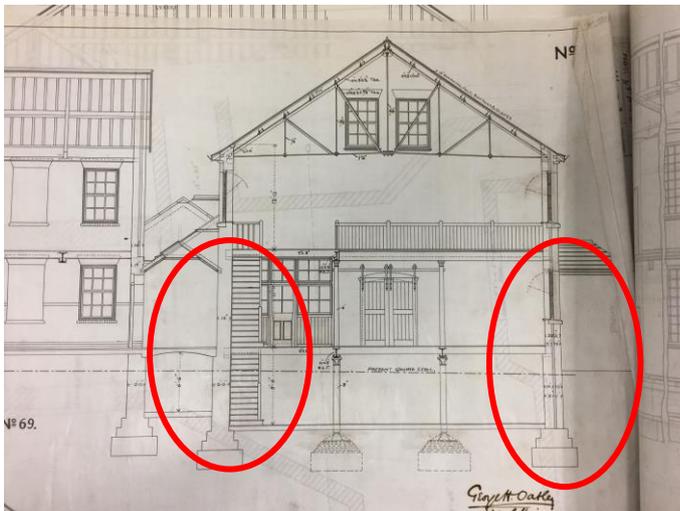
Architects drawings show a difference in construction between the north and south elevations.

Image 58, Showing the differing construction types between the north and south external walls of the stores, source: Author's own 2020

Failing further investigation to determine all contributing factors the existing evidence shows that the front elevation has slipped approximately 40mm of the line of foundation. The implied loads relating to unknown factors cannot be known at this stage, however the presence of vertical cracks to the base of windows on the first floor gable walls suggests that only the front façade and partial areas of the flanking walls have moved. Evidence does suggest this is unlikely to relate to a foundation related issue. The DPC being bituminous can be seen to have expanded out of the joint, this a result of either the forces applied down through the masonry thus squeezing and compression of the DPC and or hot weather particularly as the façade faces south and has a large surface area combined with the abutting paving being black blue and heat absorbent. One or more of these factors could have resulted in the observed movement. A full investigation

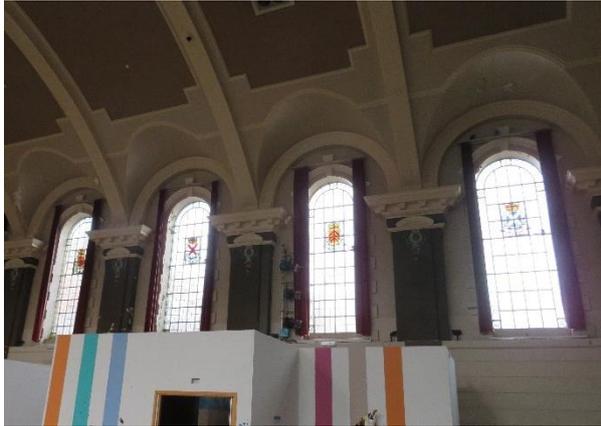
Image 60, Wrought iron windows with partial stained glass decoration, source: Author's own 2020

The condition of the windows to the hall are relatively good condition with little to no visible damage present.

Regular maintenance, operation of moving parts and decoration are required to maintain good condition.

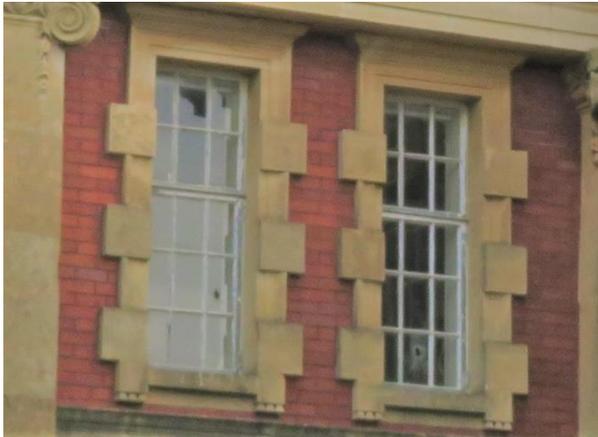
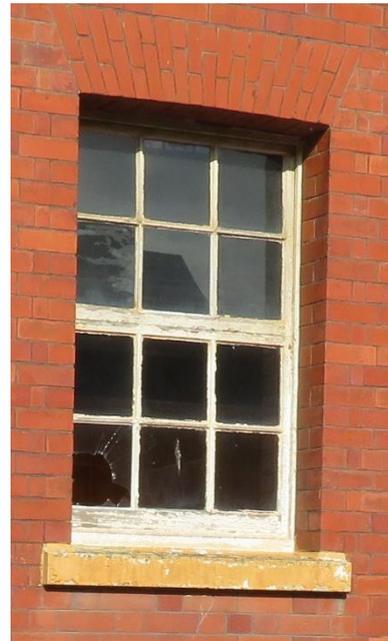
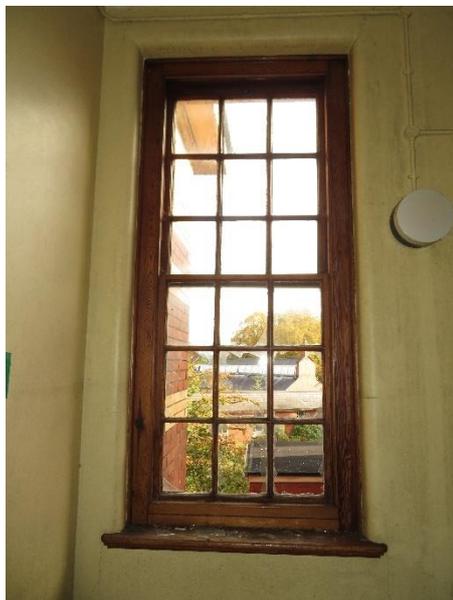
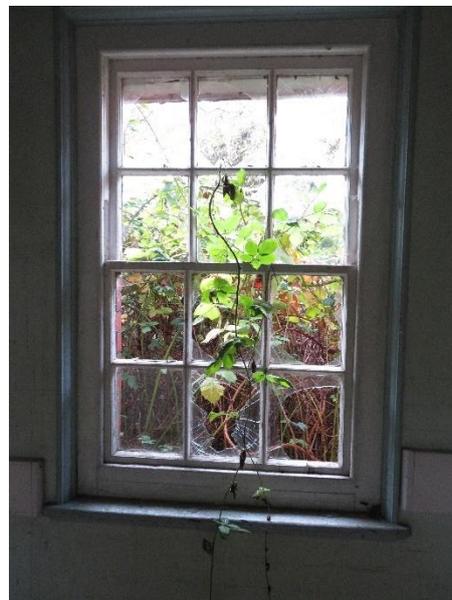
Images 61, 62, 63 & 64, showing the timber window designs found throughout the hospital, source: Author's own 2020

Whilst on the limited access tour the majority of glazing in all timber windows and several box frame sashes had experienced vandalism. This has led to the building as a whole being exposed to the ravages of the weather and wildlife. Decay had begun to set into the exposed timbers of the frames and sashes.

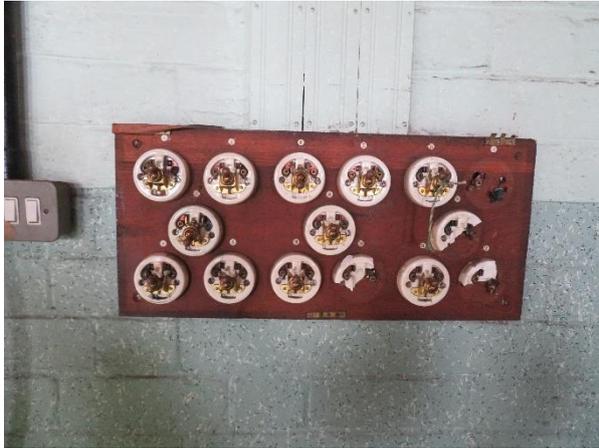
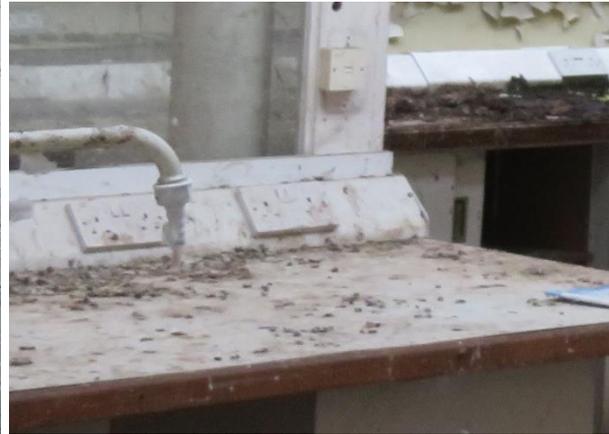
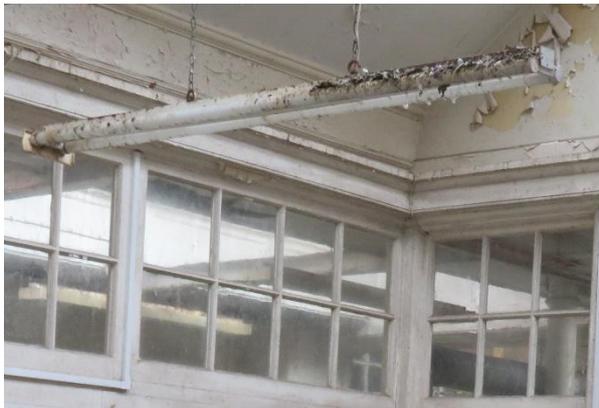
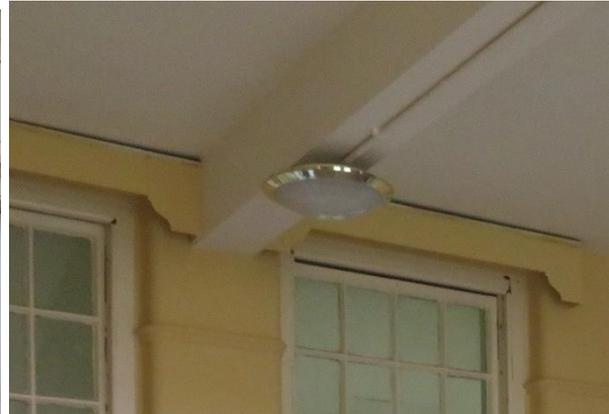
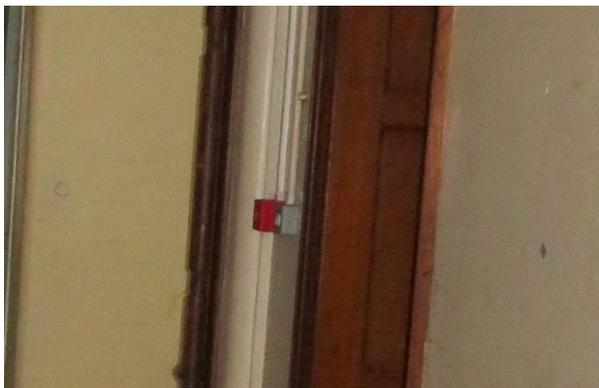
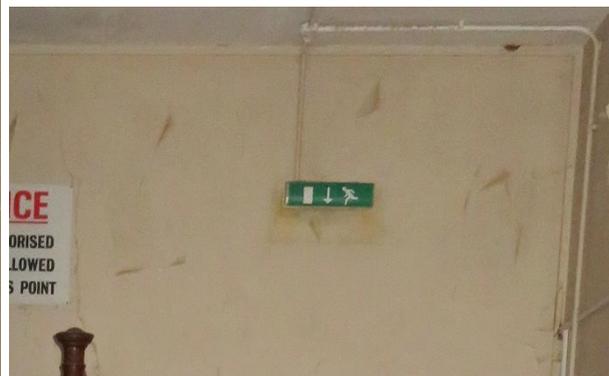
Several areas including sockets and switches have been damaged throughout the building.

Images 95, 96,97, 98, 99 & 100, Showing the electrical services found throughout the hospital, source: Author's own 2020

A full inspection to determine the condition prior to using any of the electrical services.

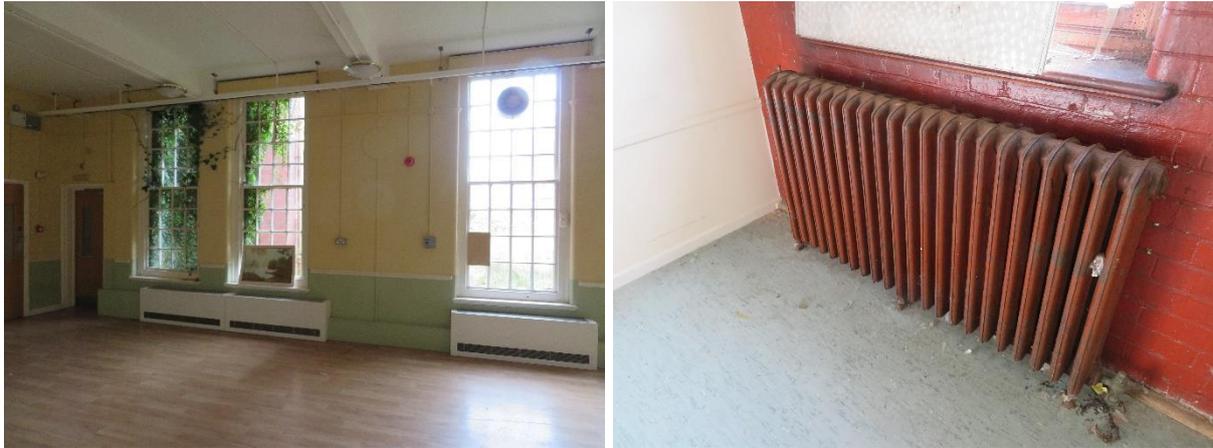
The source of heating could not be determined due to access constraints, it is assumed the heat source is via gas powered boilers however this has not been confirmed.

Images 101 & 102, Showing the heating sources found within various rooms, source: Author's own 2020

The complete system requires inspection and testing including repairs and replacement of necessary elements prior to commissioning.

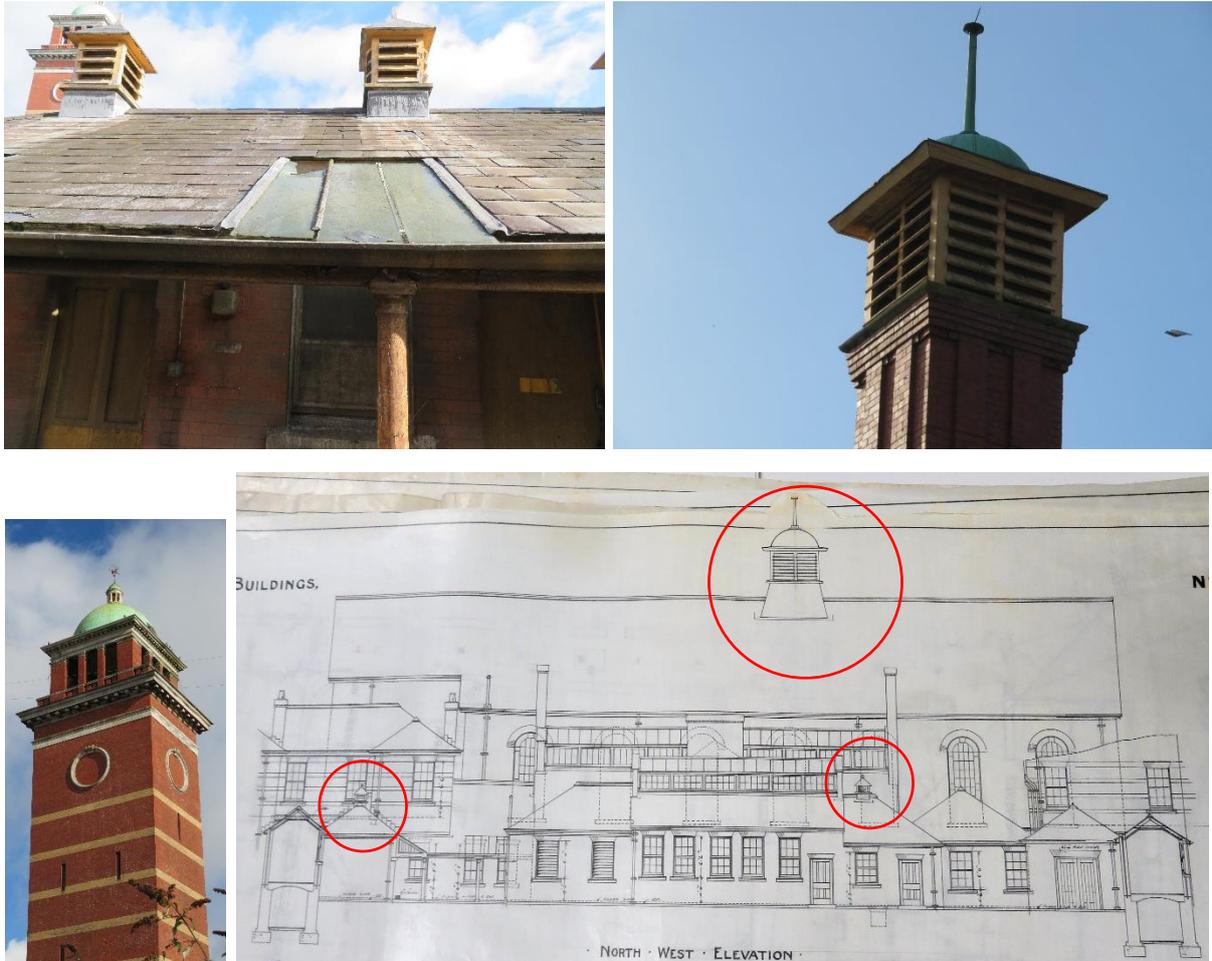
Ventilation is believed to have been built into the fabric of the buildings as seen within the water tower and multiple cupolas about the roofs of the site.

Images 103, 104 & 105 showing the various forms of ventilation towers and copulas Image 106 taken from architects plans showing the ventilation arrangements, source: Author's own 2020

It is highly likely that these ventilation cupolas and towers have become home to several species of wildlife, full investigation of these areas are required via an approved ecologist prior to recommendations being provided.

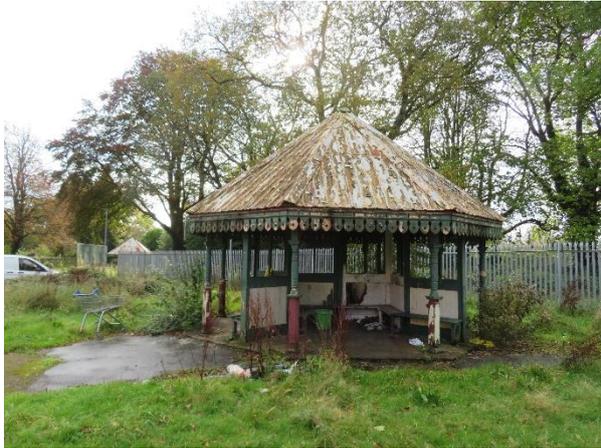
Image 108, Octagonal shelter, 1 of 6, source: Author's own 2020

The octagonal shelters viewed appeared to be in surprisingly good condition considering the exposure to weather conditions. The protection offered by the cast iron bases to the foot of the timber pillars and the good condition of the roof have prolonged the life of the timber elements. A thorough clean and minor repairs are recommended prior to complete redecoration.
